# Construction Progress Report

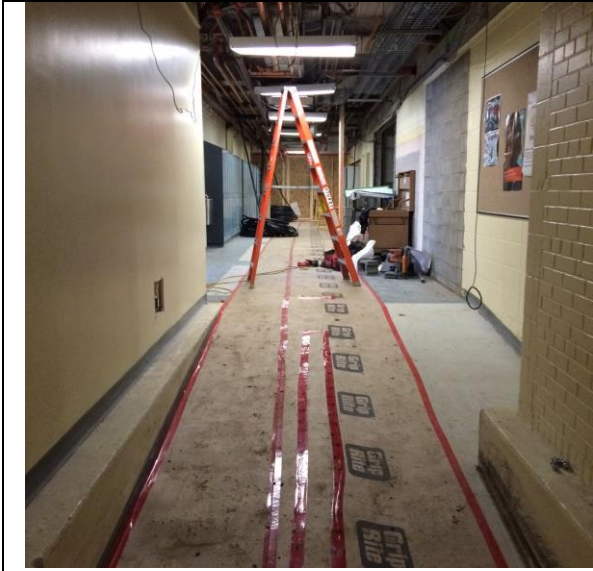
4.1- Rough in's in Corridor 1033

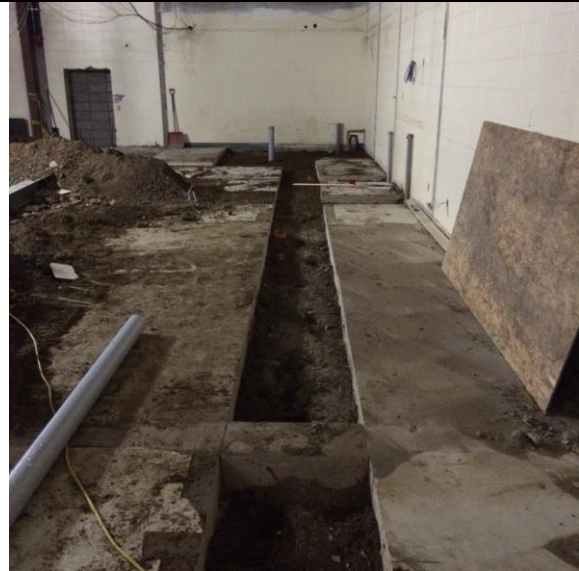
4.2- Food Studies u/s Plumbing being backfilled

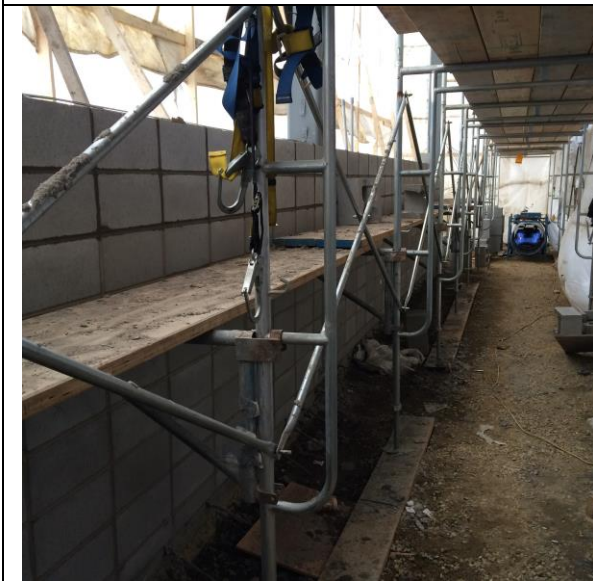
4.3- Concrete Block Walls NW Corner Gym.

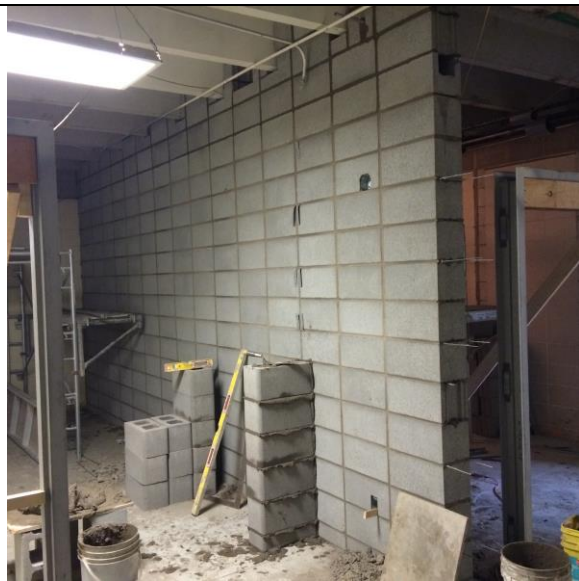
4.4- Block partition in Change Rooms

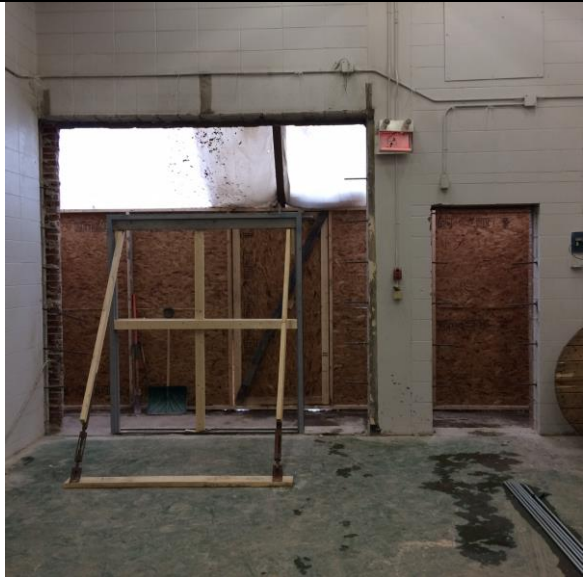
4.5- Electrical Room wall infill

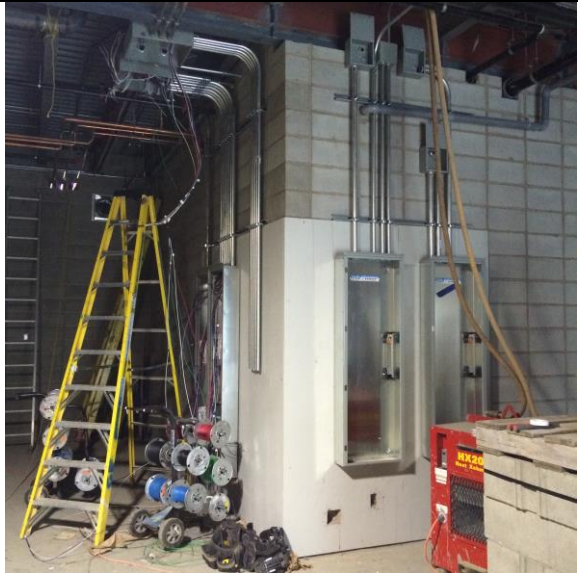
4.6- Electrical rough in's in Gym storage

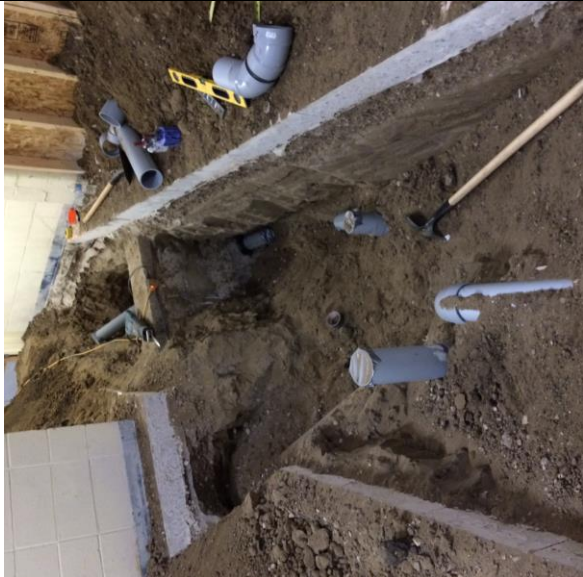
4.7- Commercial Kitchen u/s plumbing in progress.

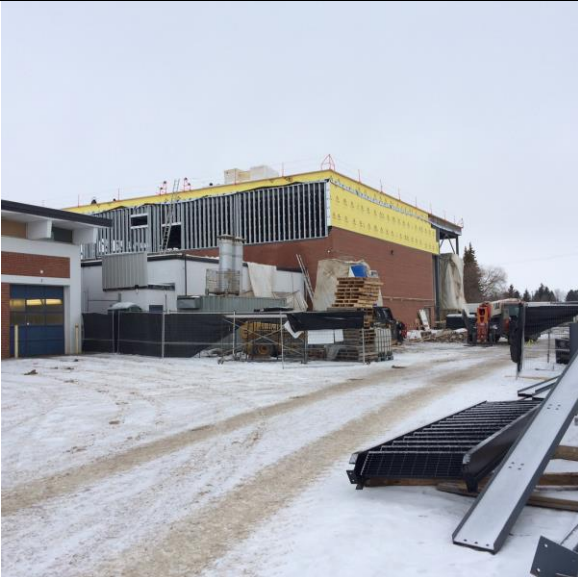
4.8- Gym steel metal stud walls.

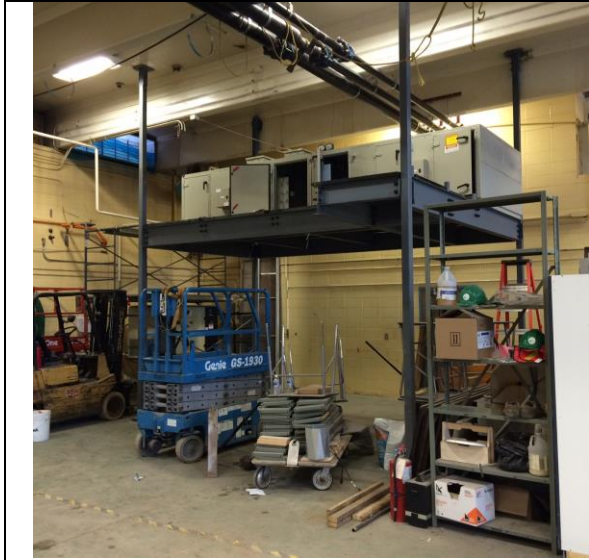
4.9- Maintenance room AHU Platform.

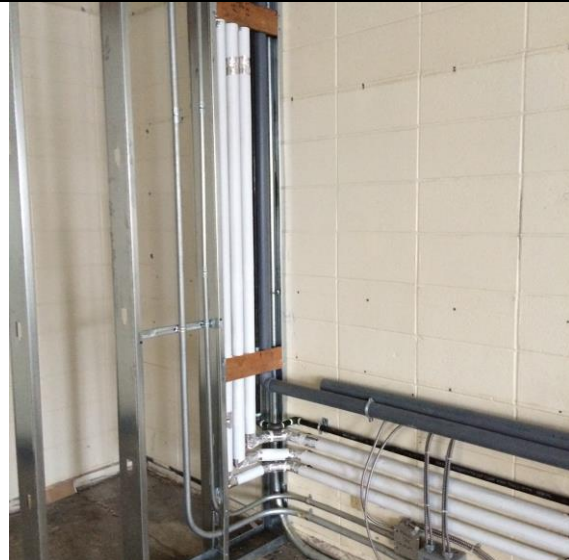
4.10- Science rooms Plumbing Insulation

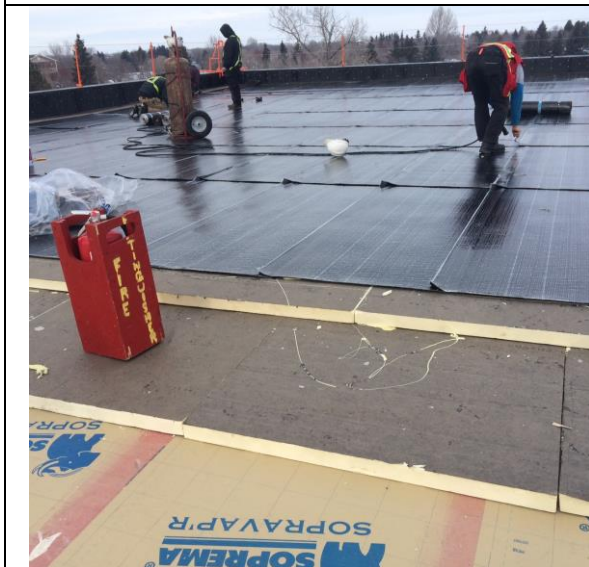
4.11- Gym Roofing progressing.

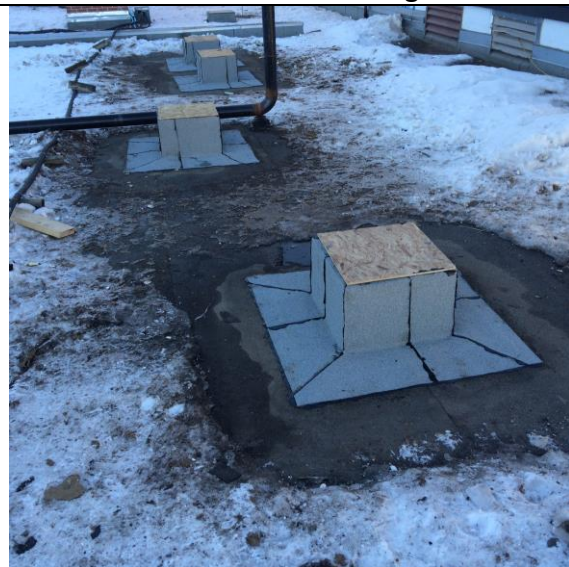
4.12- New roof penetrations on existing roof.
